WALNUT PARK  
Petaluma Boulevard and D Street  
Petaluma  
Sonoma County  
California

HALS CA-28  
CA-28

WRITTEN HISTORICAL AND DESCRIPTIVE DATA

HALS NO. CA-28

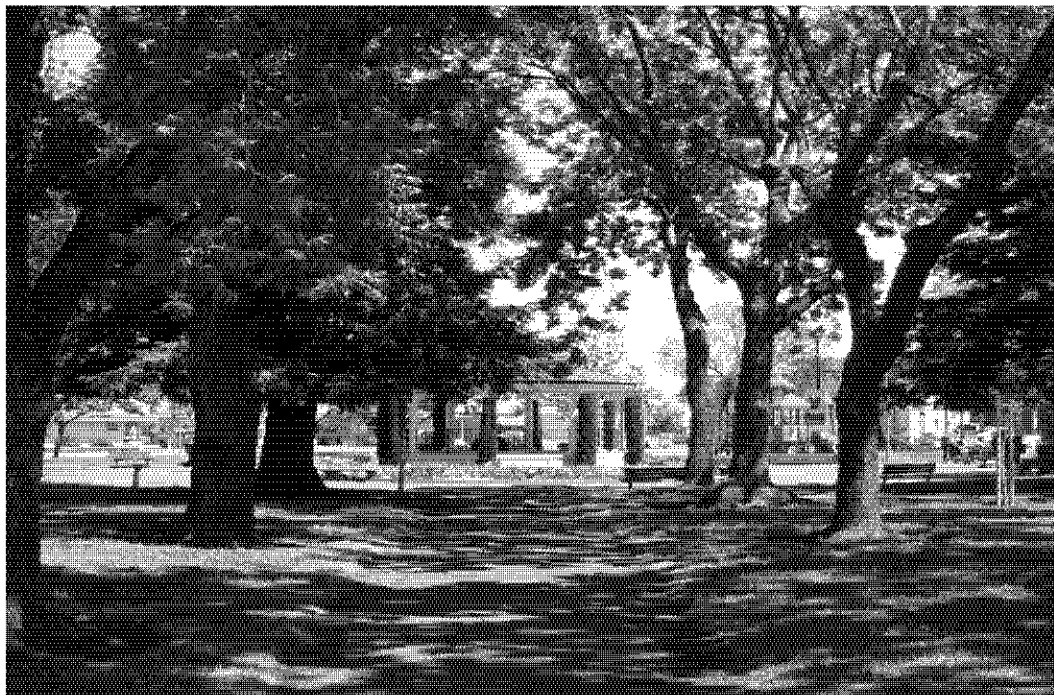
The park bandstand at the terminus of the path with the play area visible to the right (Janet Gracyk, May 6, 2008).

- The octagonal band stand is about three feet above grade and has a concrete base, concrete columns, and a concrete roof with recessed lights and is coated with a metal roof. Iron rails mark the edge of the structure. The play area is demarcated by a low wall made of concrete masonry units. Colorful metal and plastic premanufactured climbing and play equipment fills the sand-floored area. The storage structure is single story stucco with a bas-relief squirrel over the front door.

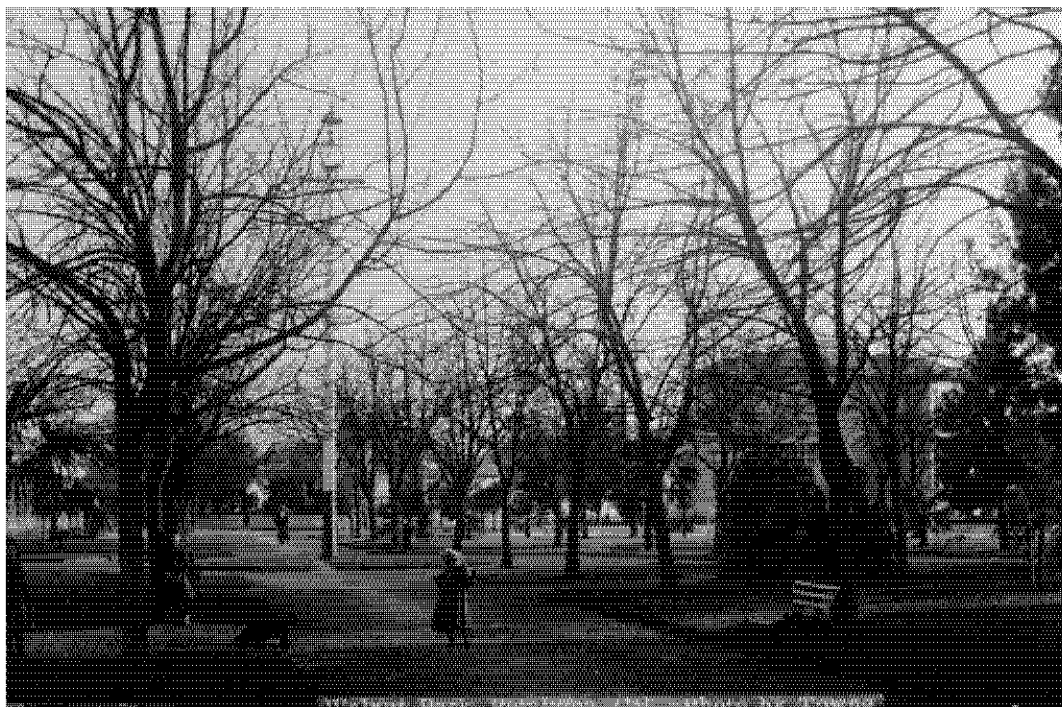
An undated historic postcard of the park sometime after the work of the Ladies' Improvement Club, showing wide paths, many trees, and the donated benches (Petaluma Historical Library and Museum).
